ASPIRATING SEAL GE90 TEST

2001 NASA Seal/Secondary Air System Workshop

Objective: Complete the Development of the Aspirating Seal for Engine Applications by Demonstrating the Seal in the GE90 Engine After Rig Verification

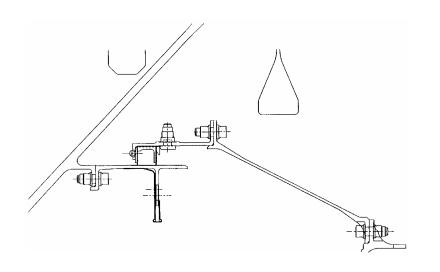
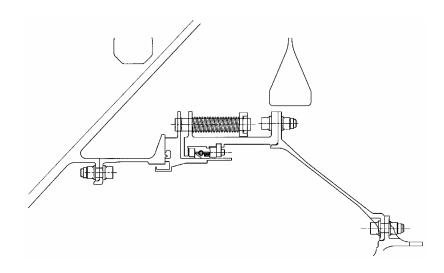
Seal Position

Aspirating Seal

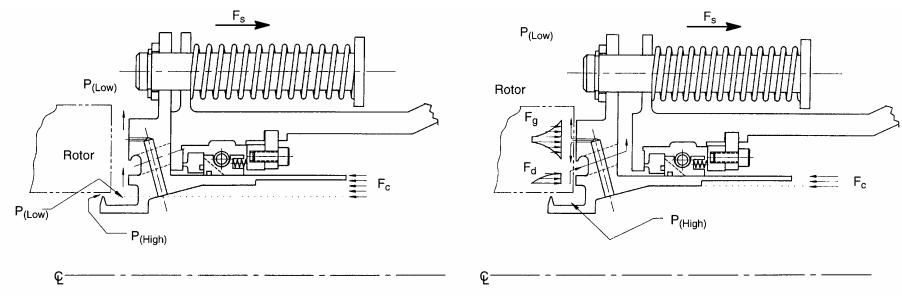
Aspirating Seal at Shutdown Phase

Aspirating Seal at Steady-State Operation

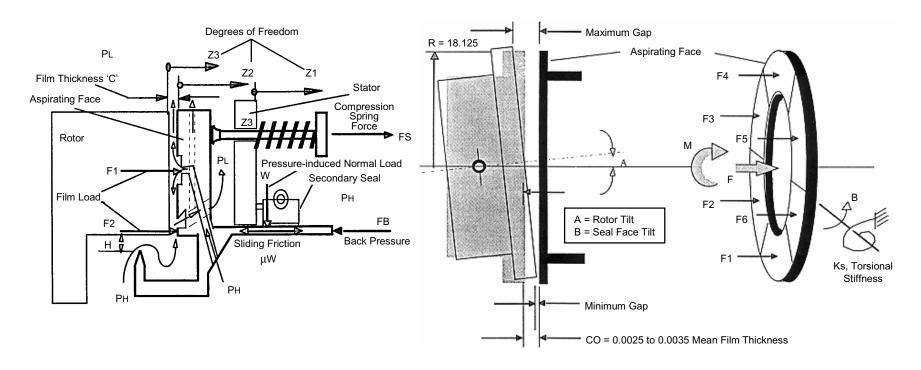
Seal Analytical Model

Transient Dynamic Model of an Aspirating Face Seal

Tilt Analysis of an Aspirating Seal

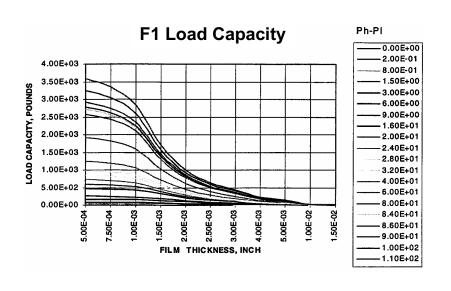
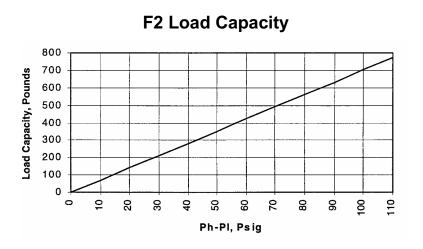
Seal Analytical Model

Variation of Load Capacity, F1, of the Main Hydrostatic Film Bearing with Film Thickness and Pressure Drop Variation of Load Capacity, F2, at the Seal Dam with Pressure Drop

Note: Loads were Derived from SCISEAL.

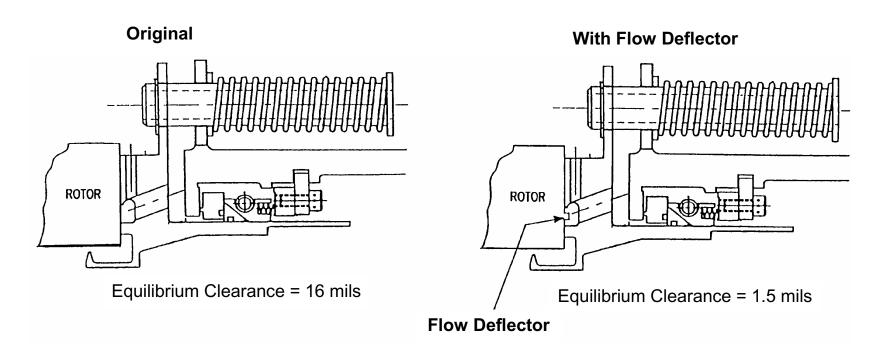
Seal / Rotor Configurations

Flow Deflector Eliminates the Mixing of Flows from Air Dam and Air-bearing Regions.

Mixing Flows Produce Excessive Pressure within Air-bearing Region

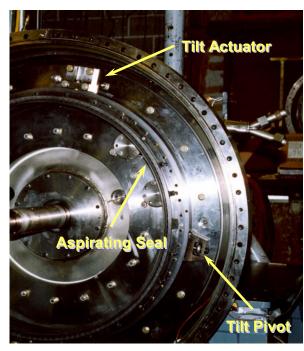
Full-scale Rig

- 15-inch Diameter Subscale Tests
 - 1000 hours Endurance Test (760 fps, 1000°F, 99 psid)
 - Dust Ingestion Test
 (400 fps, Room Temperature, 100 psid)
- 36-inch Diameter Full-scale Rig Tests (400 fps, Room Temperature, 100 psid)
 - Start / Stop Cycles
 - Runner Axial Face Runout: 5 and 10 mils
 - Simulated Maneuver Tilt

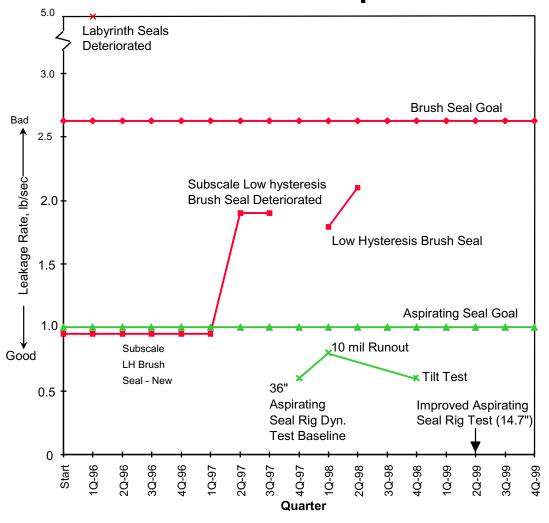
Seal Performance Comparison

- Met Seal Leakage Goal
- Exhibited Less than Half Deteriorated Brush Seal Leakage
- Non-contacting Operation Provides for No Deterioration

- Leakage Rate-Goals / Status for Brush Seals
- Aspirating Seals

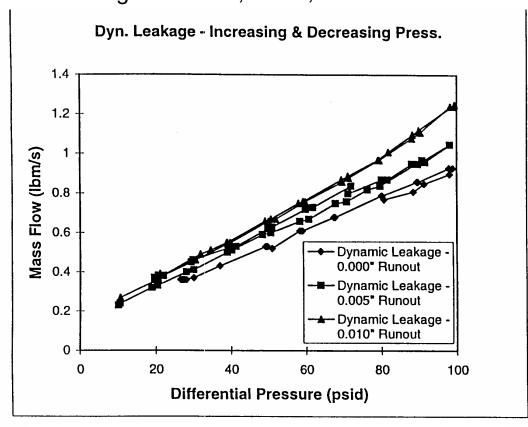
Test Results with Flow Deflector

Dynamic Leakage for 0.000, 0.005, and 0.010-inch Rotor TIR

Seal Closure Occurs at 2-3 psid for All Cases

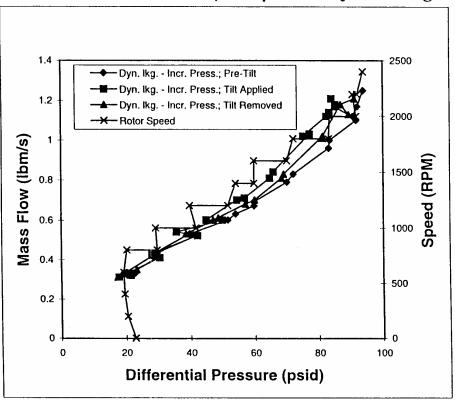
Test Results - Dynamic Leakage with Tilt

Tilt 0.27° in 0.4 second, Hold to Collect Data, Remove in 0.4 second Note: 0.007-inch Rotor Axial TIR, 141 µin. Rotor Surface. Roughness

At Maximum Conditions, Pressure Falls by 10% with Tilt While Leakage Remains Essentially Constant; Recovery Is > 95%

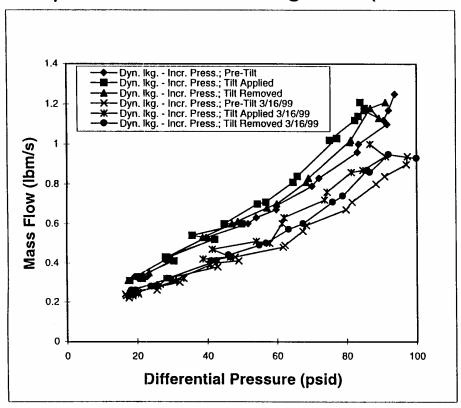
Test Results - Dynamic Leakage with Tilt

Comparison of Seal Performance with 141 μin. Rotor Surface Roughness and 13-19 μin. Rotor Surface Roughness (03/16/99 data).

• Seal Performance Improves by 24% at Maximum Conditions When Rotor Surface Roughness is Improved to 13-19 μin

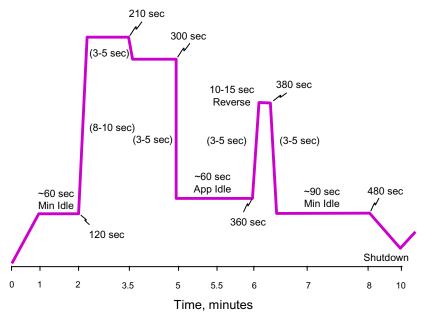
C-Cycle

Goal: 250 Test Hours with 1000 C-Cycles

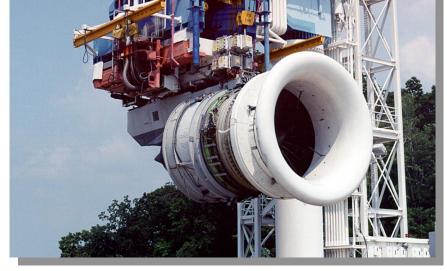
GE90 Test Stand
